**Environmental  
Assessment:  
Trans Canada Highway No.  
1 Malahat Corridor  
Improvements, Vancouver  
Island, BC**

January 2024 | Final Report Revision #1

Submitted to Ministry of Transportation & Infrastructure  
Prepared by McElhanney Ltd.

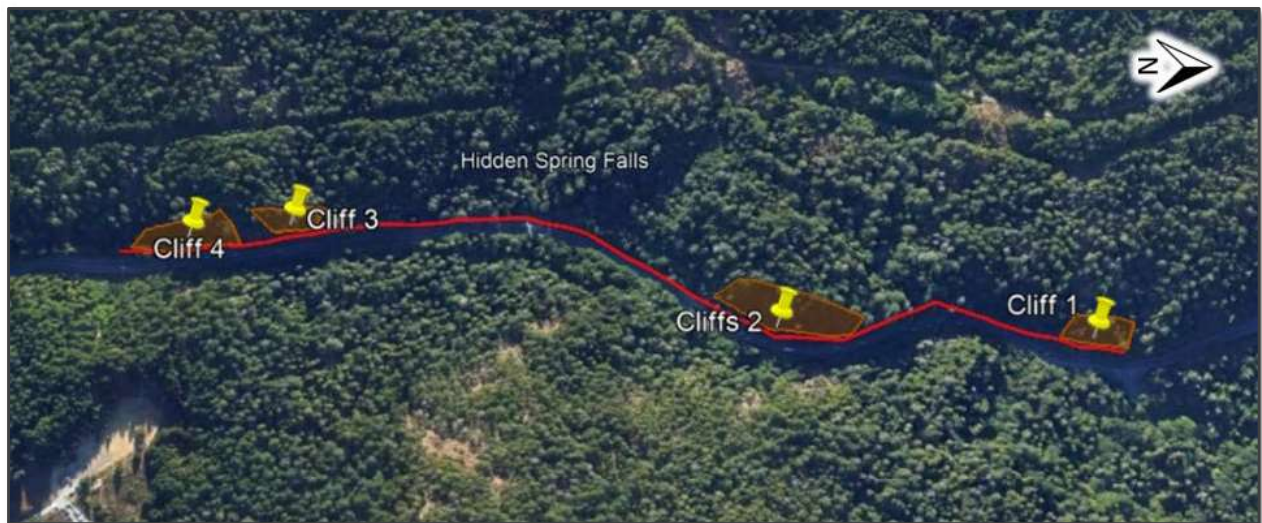
*Figure 3. Cliff areas along the highway alignment that were surveyed for bat activity. The approximate Project alignment is indicated in red (base map courtesy of Google Earth 2023).*

Observational and acoustic surveys were located at four rock zones (*Figure 3*) along the west side of the highway alignment, and along the forested areas on the eastern side of the highway (*Appendix B*). Acoustic survey sessions relied on the use of an Echo Meter Touch 2 Pro Handheld Detector (EMT Pro) from Wildlife Acoustics. The EMT Pro was used to survey the Project footprint for evidence of echolocation calls from bats flying in the vicinity (within 50 m) of the detector. These recording devices consist of an ultrasonic microphone which is plugged into a smart phone or tablet and the user can see the sonogram of the echolocation calls and also see AutoID results (refer to *Figure 4*, below). The EMT Pro also records the calls for future analysis.

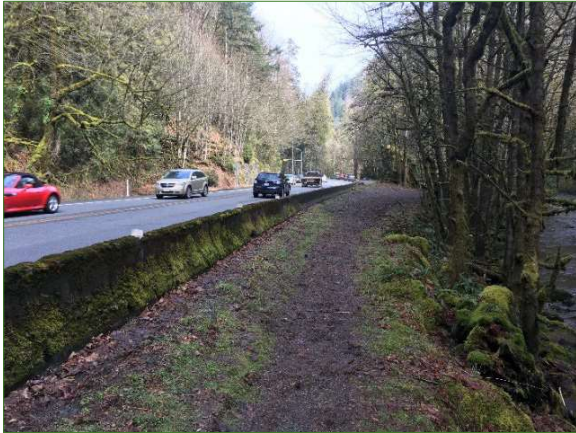
*Photo 1. East side Highway barrier, foot path and Goldstream River, north view.*

The Project footprint lies within the existing highway right-of-way (ROW), adjacent to the Goldstream River Provincial Park property boundary. Existing features immediately adjacent to the current highway footprint include a gravel parking area, a gravel footpath, a grassy vegetated shoulder, drainage swales, cliffs, and the Goldstream River (*Photo 1* and *Photo 2*).

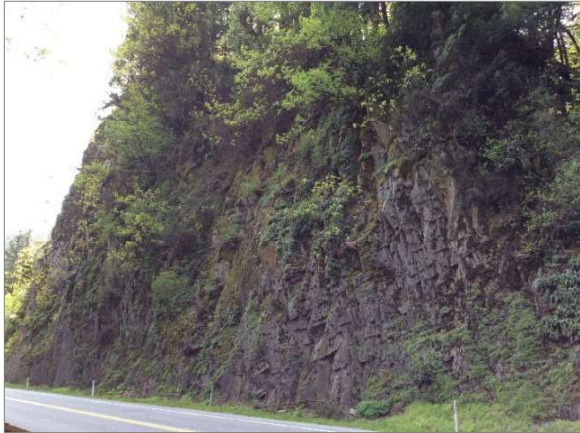
*Photo 2. Cliff boundary on the west side of the Highway, west view.*

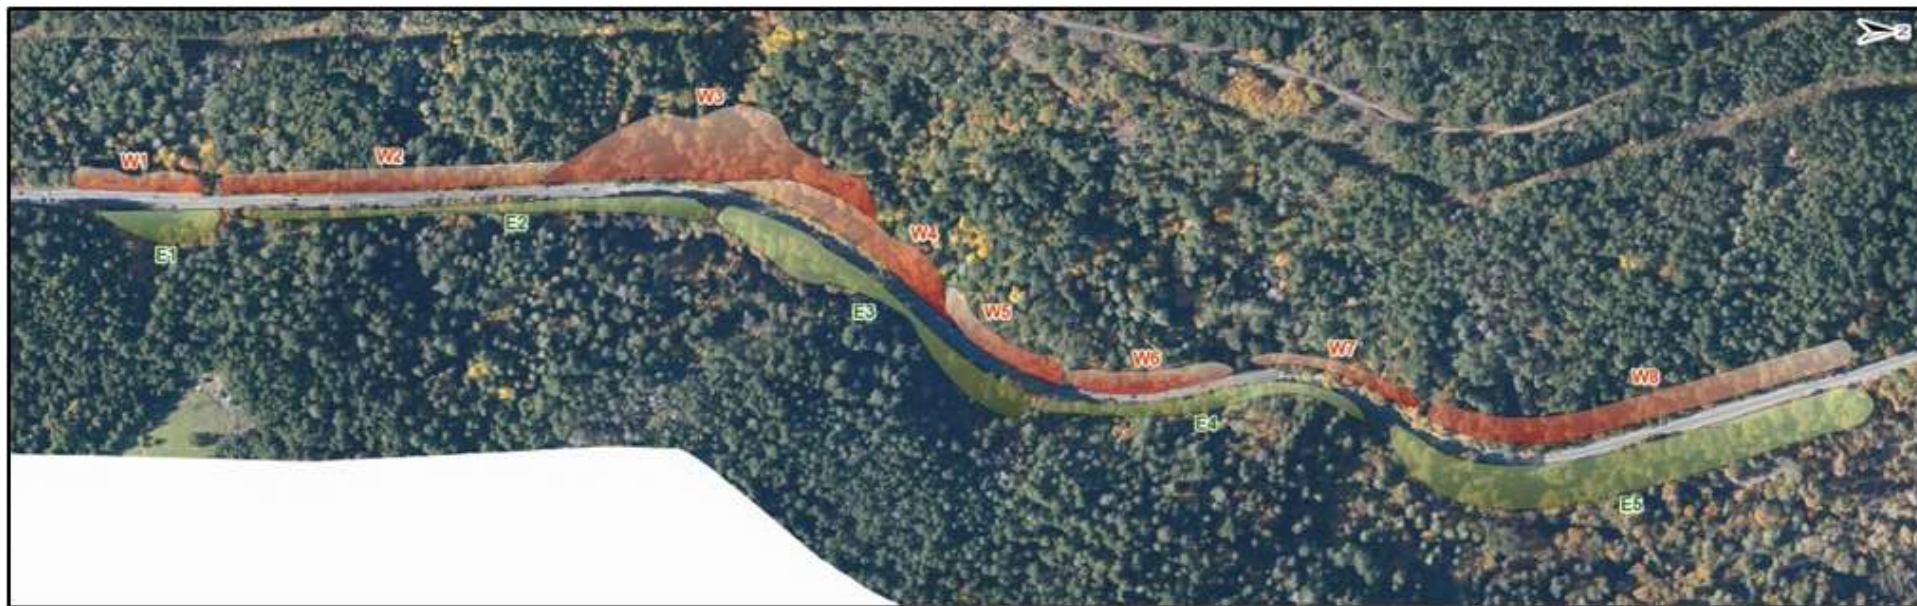
Figure 7. Map of the approximate location of vegetation communities identified as overlapping with the Project footprint (W = west side of highway alignment; E = east side of highway alignment).

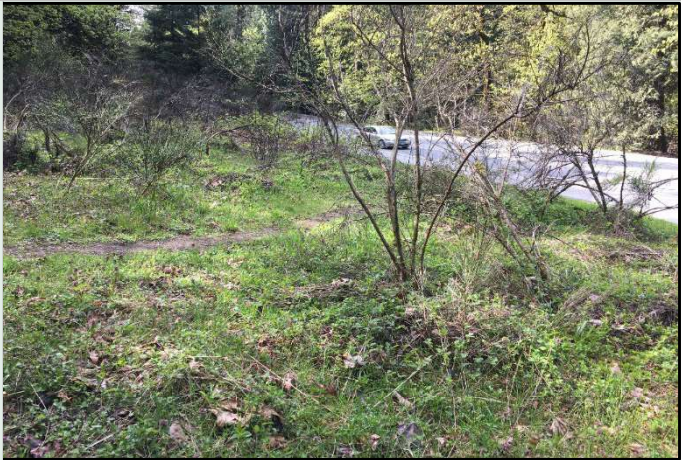
| Location | Photo Representation | Description of Vegetation Community |
|---|---|---|
| E1 | | A herb and shrub layer largely dominated by invasive species. Soils within E1 appeared to be comprised of fill from previous highway works. The vegetation community was dominated by the invasive Scotch broom ( <i>Cytisus scoparius</i> ), and dandelion ( <i>Taraxacum</i> sp.), as well as trailing blackberry ( <i>Rubus ursinus</i> ), a native plant species. Other species included Western flowering dogwood ( <i>Cornus nuttalli</i> ), bigleaf maple ( <i>Acer macrophyllum</i> ), red alder ( <i>Alnus rubra</i> ), and cloudberry ( <i>Rubus chamaemorus</i> ). |

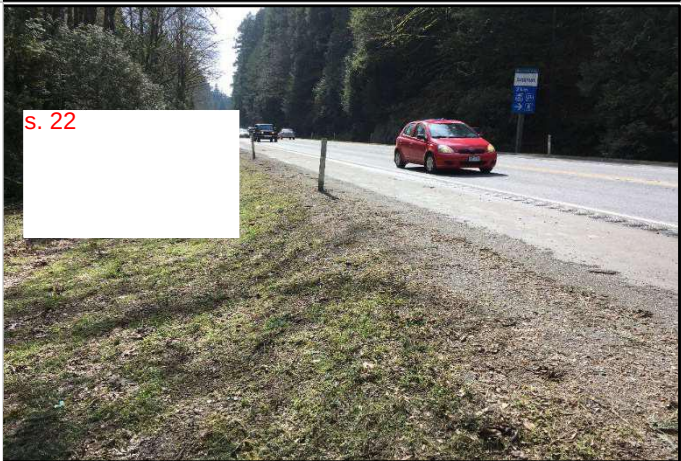
| Location | Photo Representation | Description of Vegetation Community |
|---|---|---|
| E2 | <div>s. 22</div> | A flat bench of grasses and herbs are present along the footpath that runs parallel to the highway. The primary species include the invasive plant species smooth brome grass ( <i>Bromus inermis</i> ) and cleavers ( <i>Galium aparine</i> ), as well as miner's lettuce ( <i>Claytonia perfoliate</i> ), and trailing blackberry (both native species). The topography slopes from the highway down towards the Goldstream River where Western redcedar ( <i>Thuja plicata</i> ), sword fern ( <i>Polystichum munitum</i> ), and bigleaf maple are dominant. |

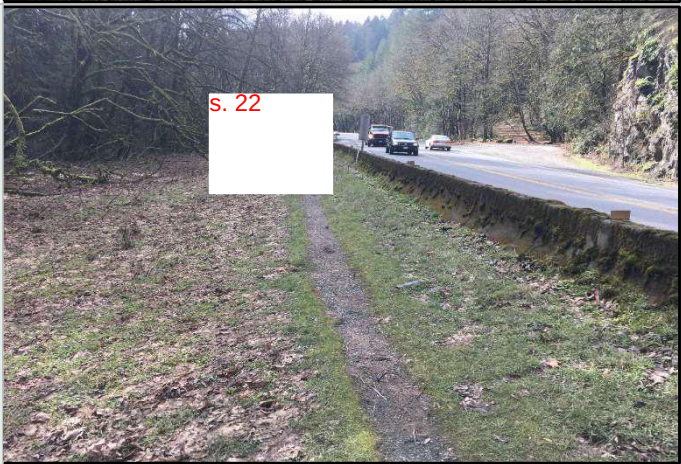
| Location | Photo Representation | Description of Vegetation Community |
|---|---|---|
| E3 | <div>s. 22</div> | Two benches are present in this location as the Goldstream River meanders away from the highway. The dominant species include Western redcedar and bigleaf maple, with an understory of sword fern, salmonberry, evergreen huckleberry ( <i>Vaccinium ovatum</i> ) and an herb layer of invasive species including cleavers, smooth brome grass, dandelion and dove's foot geranium ( <i>Geranium molle</i> ). |

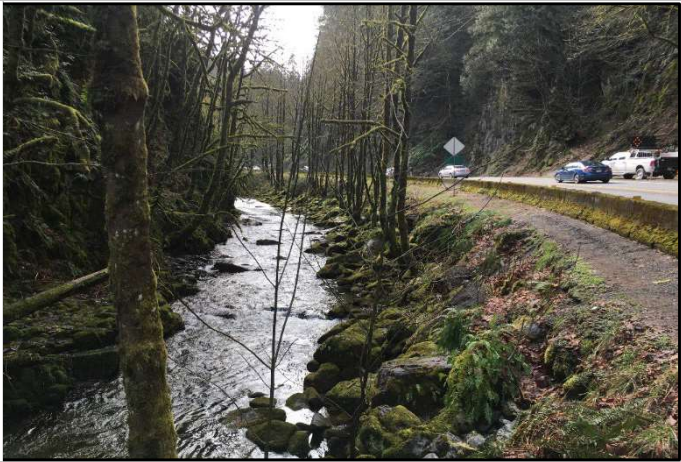
| Location | Photo Representation | Description of Vegetation Community |
|---|---|---|
| E4 | | A steep retaining wall is present along the highway alignment at this location. Bigleaf maple occur near the wetted edge of Goldstream River. Gravel substrates were observed adjacent to the edge of the highway barrier. Grasses and herbs are growing in areas not occupied by compacted gravel or boulders. |

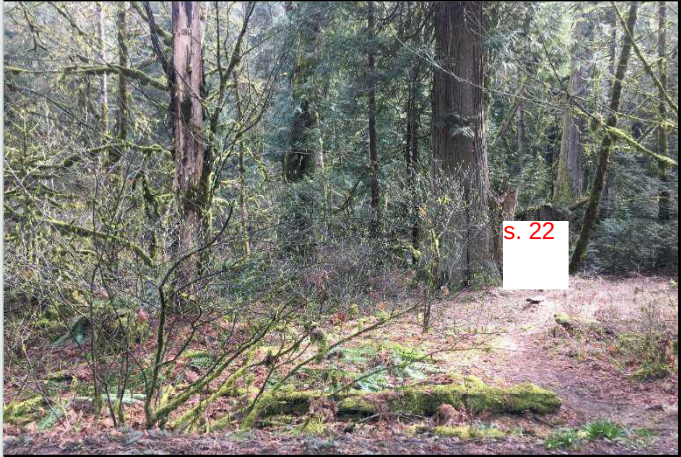
| Location | Photo Representation | Description of Vegetation Community |
|---|---|---|
| E5 | | The Goldstream River meanders away from the Highway alignment at this location. Gravel substrate occurs adjacent to the Highway barrier. This area is used by park visitors as an unofficial parking lot on the south side of Finlayson Arm Road. To the north of Finlayson Arm Road a retaining wall separates the gravel shoulder of the highway from a Western redcedar, sword fern, and Pacific waterleaf ( <i>Hydrophyllum tenuipes</i> ) vegetation community. |

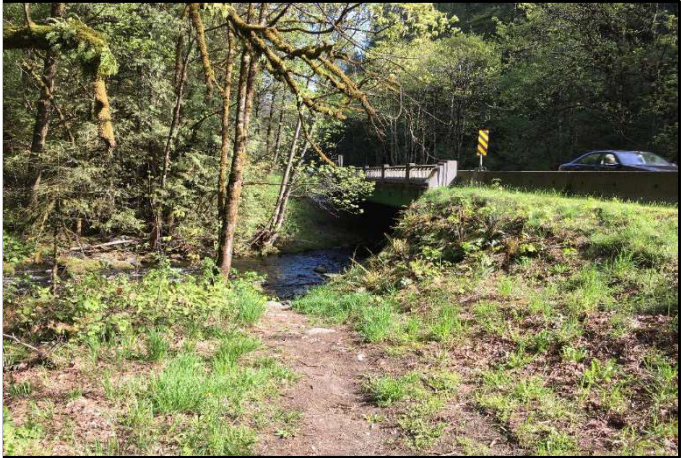
| Location | Photo Representation | Description of Vegetation Community |
|---|---|---|
| W1 | | Immediately adjacent to the highway footprint is a gravel pull out and BC Parks information sign. Natural forest habitat occurs beyond this location consisting of a canopy layer of bigleaf maple, Western redcedar, Western hemlock, and juvenile red alder. The shrub layer consisted of predominantly sword fern, dull Oregon grape ( <i>Mahonia nervosa</i> ), salmonberry, cloudberry, and salal ( <i>Gaultheria shallon</i> ). The herb layer consisted of invasive species including smooth brome grass, wild carrot ( <i>Daucus carota</i> ), and giant mullein ( <i>Verbascum Thapsus</i> ). |

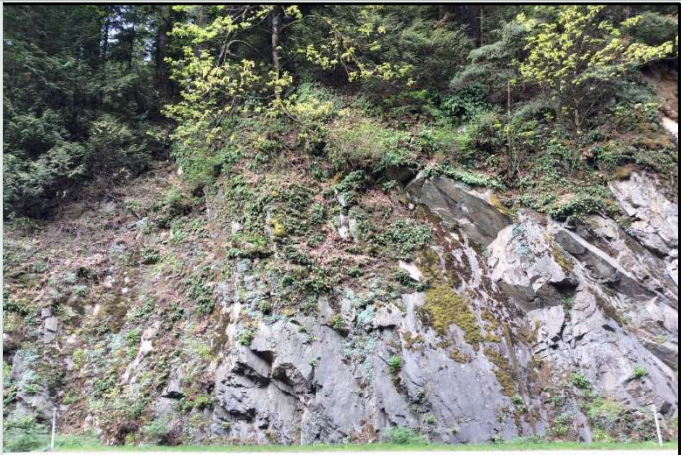
| Location | Photo Representation | Description of Vegetation Community |
|---|---|---|
| W2 | | A shoulder swale that includes a herb layer of predominantly invasive species was observed in this location. A steep cliff bank extends beyond the highway shoulder that includes Western redcedar, bigleaf maple, Douglas-fir ( <i>Pseudotsuga menziesii</i> ) and Western hemlock trees along with a number of wildlife trees. Species observed on the rock face included stonecrop ( <i>Sedum</i> sp.), licorice fern ( <i>Polypodium glycyrrhiza</i> ), and unidentified moss species. |

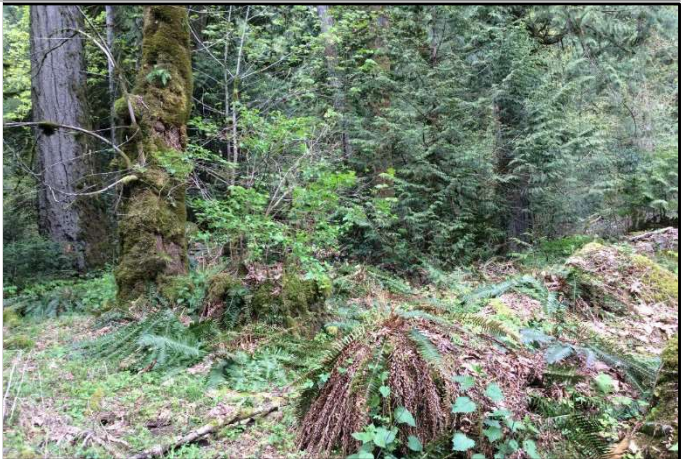
| Location | Photo Representation | Description of Vegetation Community |
|---|---|---|
| W3 | | Mature forest habitat occurs adjacent to the highway alignment in this location. The forest floor contains ample large woody debris, and the existing drainage provides moist soil conditions and riparian ecosystem characteristics. The canopy cover included Western redcedar, grand fir ( <i>Abies grandis</i> ), Western hemlock, and Douglas-fir. The shrub layer consisted of red huckleberry ( <i>Vaccinium parvifolium</i> ), salmonberry, oceanspray ( <i>Holodiscus discolor</i> ), sword fern, stinging nettle ( <i>Urtica dioica</i> ), trailing blackberry, and Pacific waterleaf observed in low lying areas. Non-native species included mullein, and English holly ( <i>Ilex aquifolium</i> ). |

Pacific Waterleaf (*Hydrophyllum tenuipes*) was observed during a Site visit as per Location W3 in [Table 7](#). This species was downgraded in 2018 from being provincially red-listed to its current status as yellow-listed, based on the species being more abundant than previously thought in combination with its strong ability to disperse in appropriate habitat and its ability to tolerate some disturbance (CDC 2018). This species still has a provincial status of S3S4, meaning it is still somewhat vulnerable to extirpation and thus should be included in the effects assessment for the Project as a sensitive plant species.

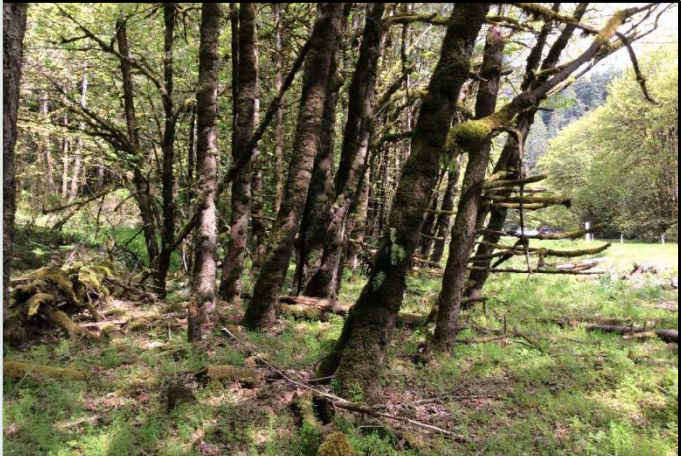
| Location | Photo Representation | Description of Vegetation Community |
|---|---|---|
| W4 | | This location included a vegetated area between the old highway alignment that is now an unmaintained gravel road, and the current highway footprint. The canopy layer consisted of Western redcedar and bigleaf maple. The shrub layer consisted of sword fern, false lily-of-the-valley ( <i>Maianthemum dilatatum</i> ), Pacific bleeding heart ( <i>Dicentra formosa</i> ), salmon berry, and huckleberry. The herb layer included invasive smooth brome grass, cleavers, and dandelion. |

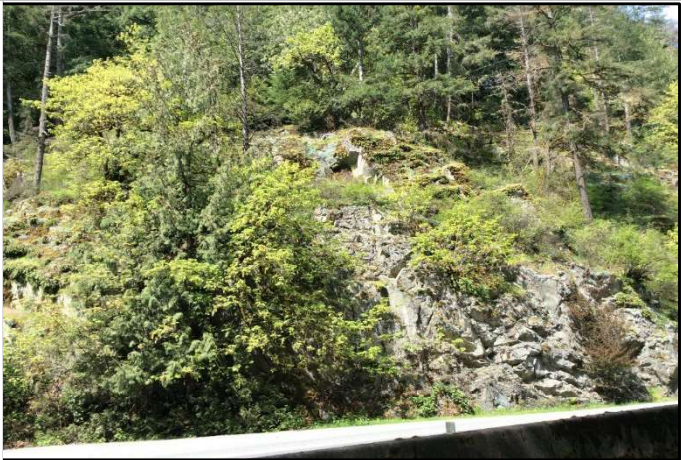
| Location | Photo Representation | Description of Vegetation Community |
|---|---|---|
| W5 | | Cliff habitat features adjacent to the highway alignment were observed in this location. Canopy cover consisted of Douglas-fir, bigleaf maple, and Garry oak ( <i>Quercus garryana</i> ) near the top of the cliffs. Licorice fern, stonecrop, sea blush ( <i>Plectritis congesta</i> ), and ocean spray were observed on the cliff face. |

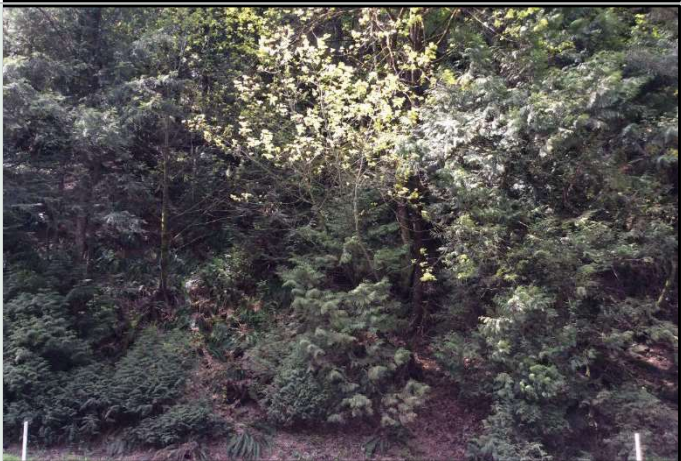
| Location | Photo Representation | Description of Vegetation Community |
|---|---|---|
| W6 | | Steep terrain with some bedrock outcrops was observed at this location, with a mix of Western red cedar, Western hemlock, bigleaf maple, and Douglas-fir canopy cover. Sword fern dominated the shrub layer. |

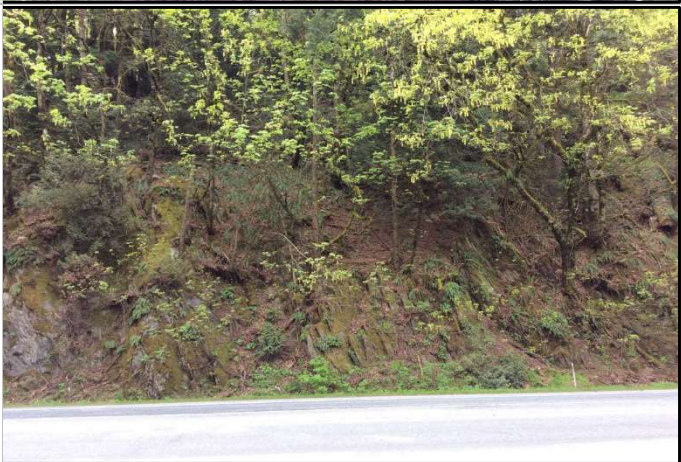
| Location | Photo Representation | Description of Vegetation Community |
|---|---|---|
| W7 | | This location consisted of a narrow highway shoulder with steep, moss-covered bedrock slopes adjacent to the highway alignment. Canopy cover consisted of Douglas-fir and bigleaf maple. Licorice fern, stonecrop, sea blush, and ocean spray are present. |

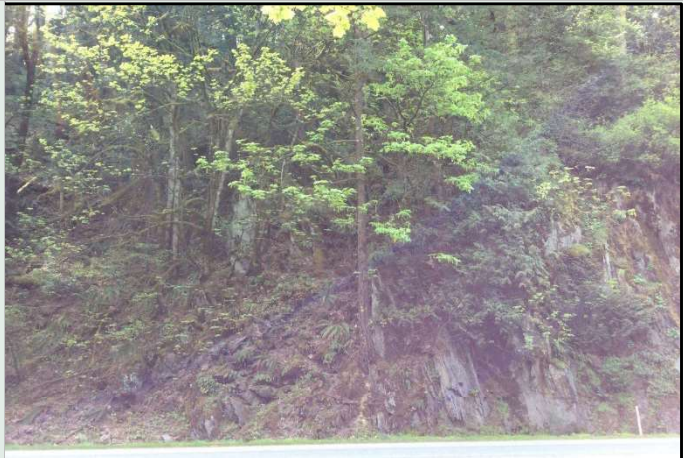
| Location | Photo Representation | Description of Vegetation Community |
|---|---|---|
| W8 | | This location consisted of a narrow highway shoulder that quickly transitioned into steep terrain with some bedrock outcrops. The canopy cover consisted of a mix of Western redcedar, Western hemlock, bigleaf maple, and Douglas-fir. Sword fern dominated the shrub layer. |

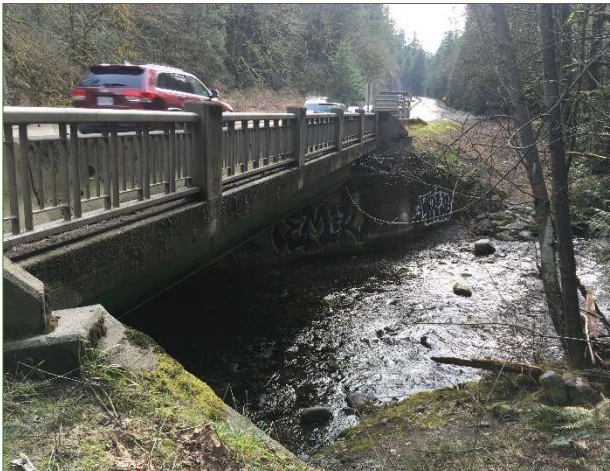
Photo 3. Goldstream River Bridge, south end of the alignment, north view.

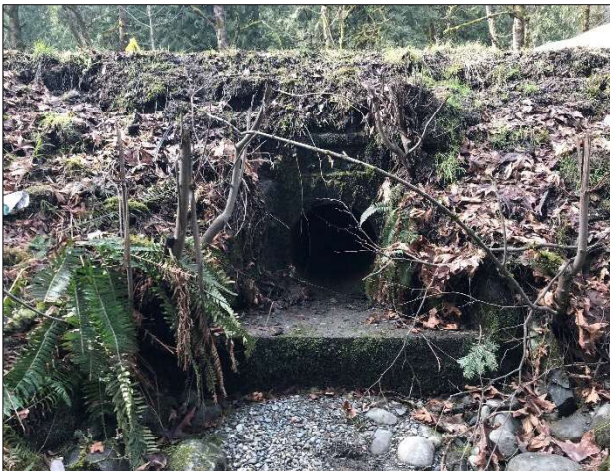
Photo 5. Culvert outlet leading to the Goldstream River, upstream view.

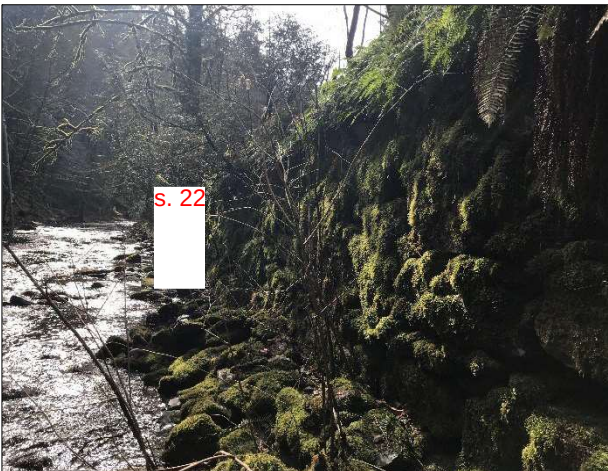
Photo 6. Example of the stone stacked wall, south view

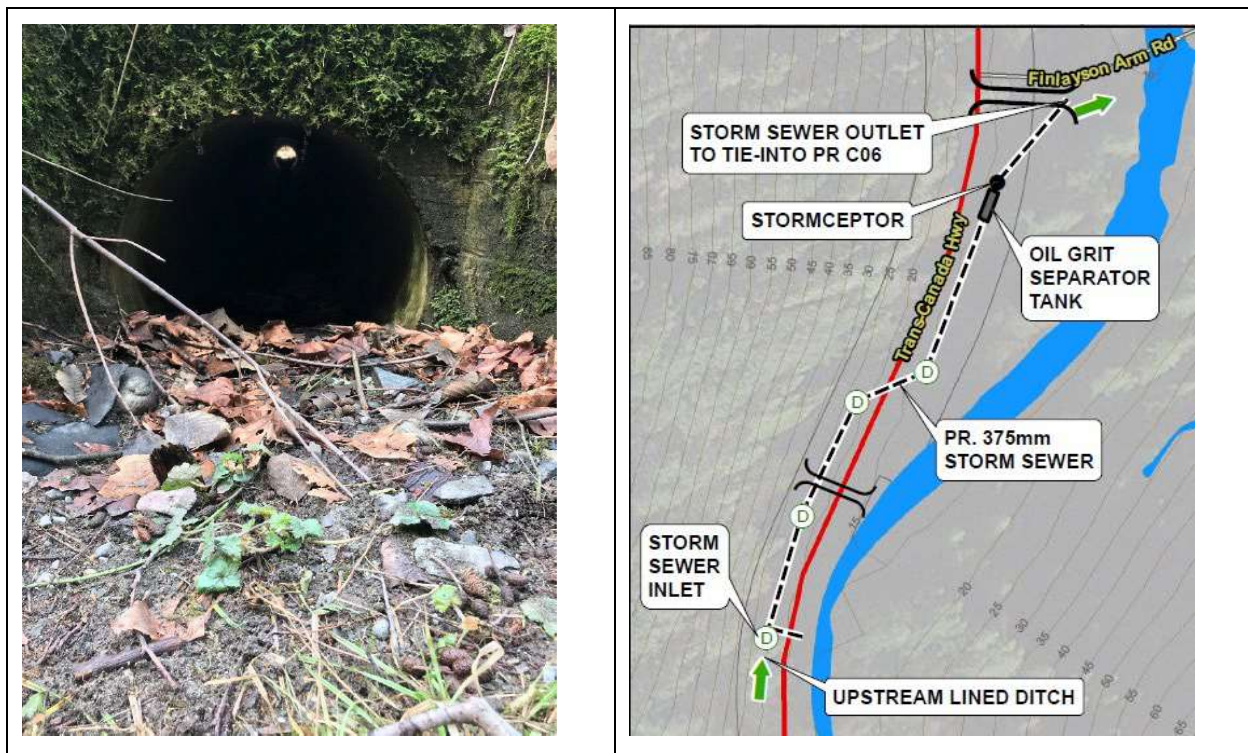
Figure 11. 100% detailed design of the stormwater management system (McElhanney 2022).

There are five existing drainage culverts within the Project footprint that range between 400 mm and 600 mm and vary in length from 15 m to 48 m (McElhanney 2022). Four of the five existing culverts are undersized and do not meet MoTI conveyance standards; these culverts will require upgrades to meet MoTI's drainage criteria. One culvert does meet the MoTI standard and does not require upgrades under the current drainage pattern; however, replacement of this culvert is warranted due to the highway being widened by approximately 2 m. An additional storm sewer has also been added to the design at the north extent of the Project to convey any surface runoff to a detention tank and oil and grit separator unit for water to be treated before discharging into Goldstream River (*Figure 11*).
